## Northstar Field Services

### Activity Information

The technician performed corrective maintenance on a commercial electrical distribution panel at the North Operations Facility in Austin, Texas.

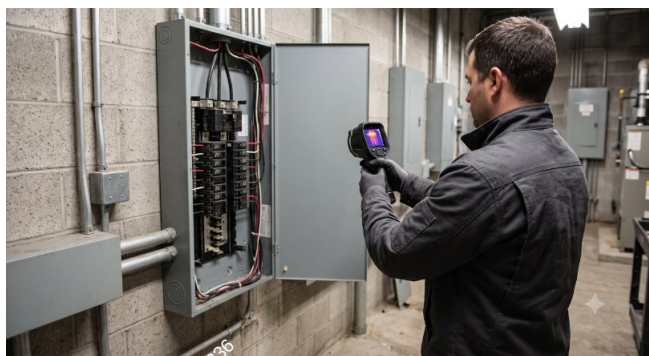
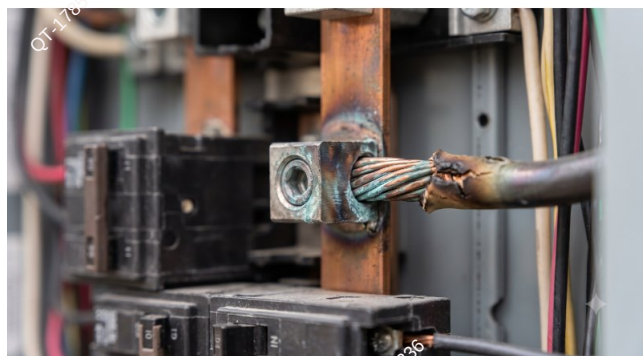
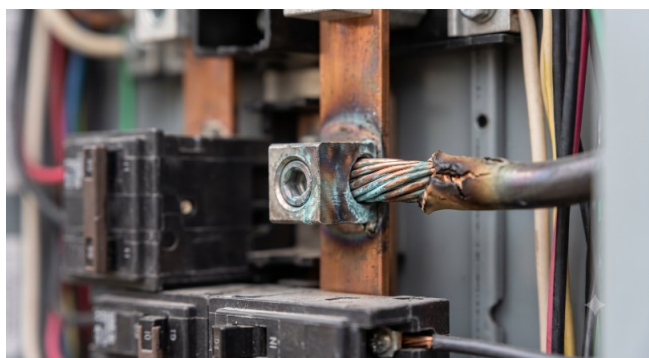
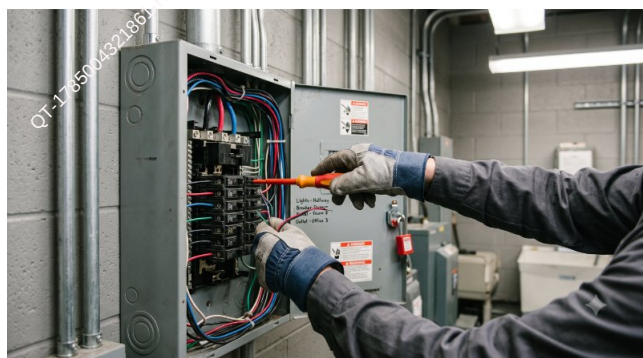
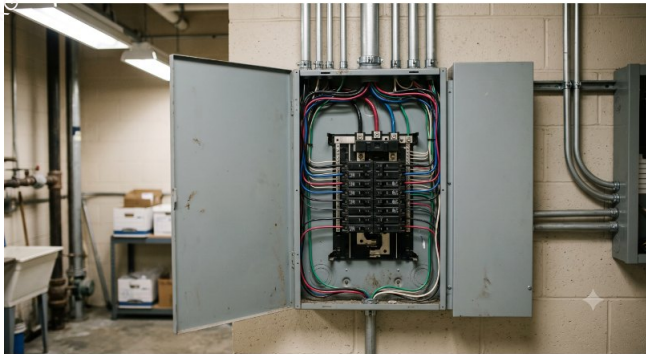
During the inspection, two worn electrical connectors showed signs of overheating, oxidation, and poor contact. The circuit was safely isolated before the intervention. The damaged connectors were removed and replaced using two electrical connector replacement kits. Two insulated terminal and heat-shrink kits were used to protect the repaired connections, and three cable labeling and wire management kits were used to identify and organize the wiring inside the panel.

After the maintenance was completed, the panel was powered back on and monitored under normal operating conditions. The repaired connections remained stable, no abnormal heating was observed, and the final operational check did not identify additional faults.
